Vol. VIII, No. 10
October, 1948

Lineman

U. S. DEPARTMENT OF AGRICULTURE

POLE TOP RESUSCITATION SUCCESSFUL

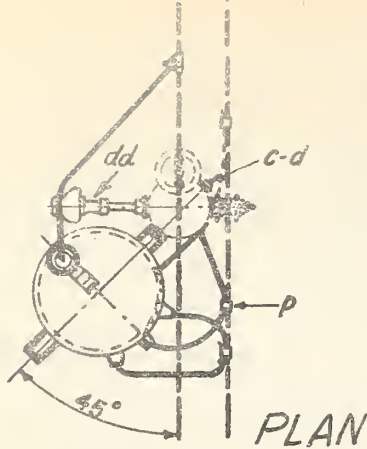
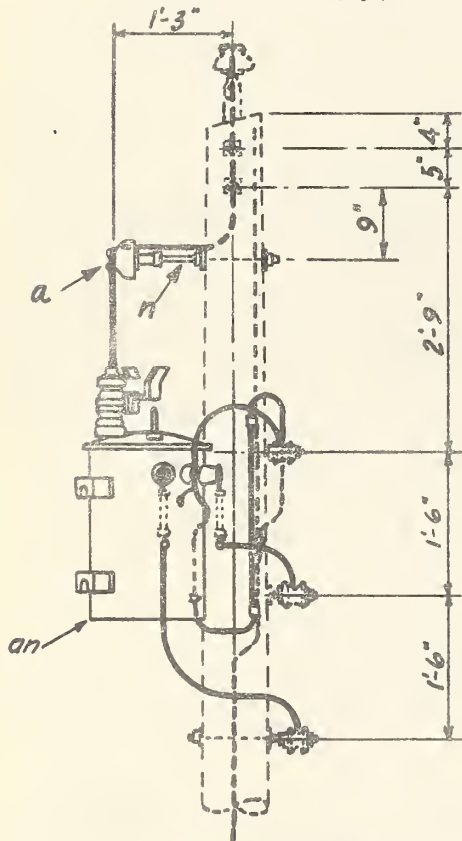
ELEVATION

ITEM	No Req'd	MATERIAL	ITEM	No Req'd	MATERIAL
a	1	Insulator, pin type	ap	1	Clamp, hot line, tap assembly
c	2	Bolt, machine, $\frac{5}{8}$ " x req'd length	aq		Leads, #6 S.D. Copper or equiv.
d	4	Washer, $2\frac{1}{4}$ x $2\frac{1}{4}$ x $\frac{3}{16}$, $\frac{13}{16}$ hole	dd	1	Adapter, insulator $\frac{5}{8}$ "
n	1	Bolt, double arming, $\frac{5}{8}$ " x req'd length	an	1	Transformer, coordinated conventional with internal fuse and double gap
p		Connectors, as req'd.
